WATERAGRI

D4.3: Description of Developed Drainage Technologies

M36, April / 2023

WP 4 Nutrient Recovery from Streams

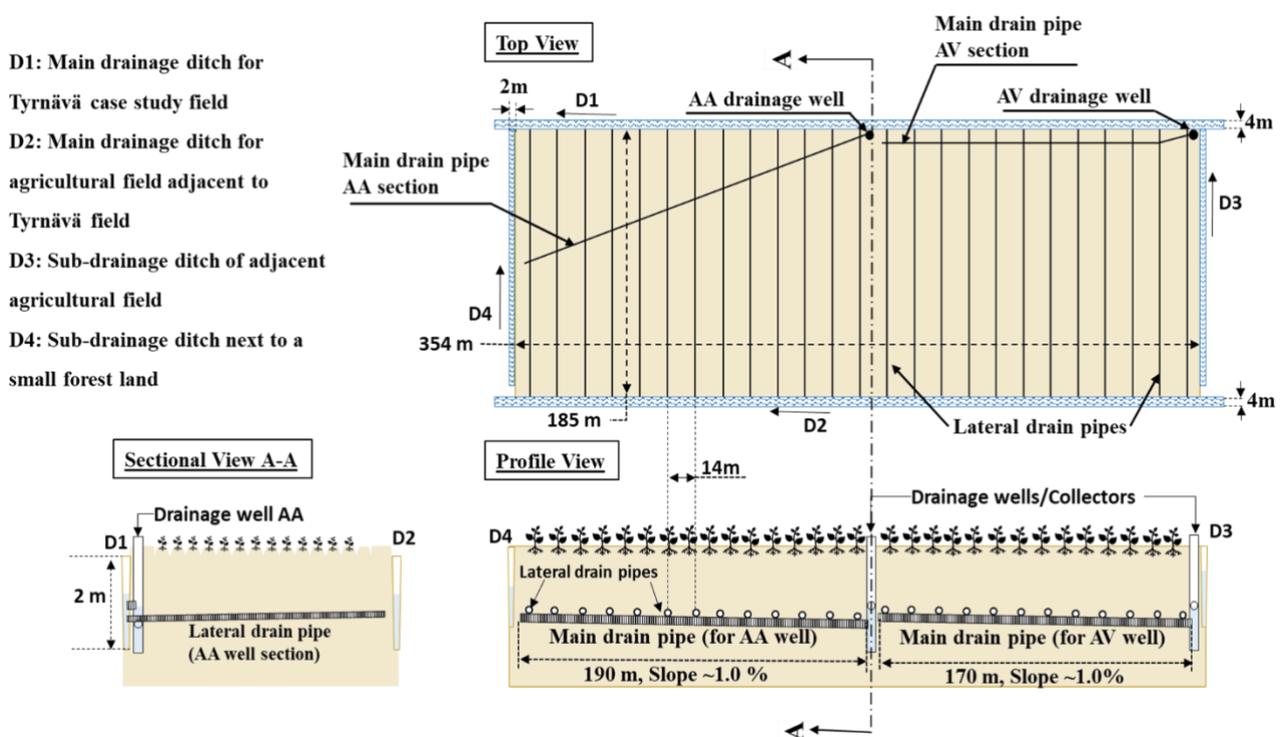
Figure 1. Schematics of subsurface tile drainage system (Top – Profile - Cross-Sectional (A-A) view) installed at Finland I -Tyrnävä case study site.

Figure 1 (top view, profile view, sectional view) presents the schematics of the subsurface drainage system installed in the Tyrnävä field study area. The case study field installed with a subsurface tile drainage system (Figure 1) consists of a total of 25 laterals (corrugated PVC pipes, \varnothing 65 mm) installed at a depth of around 1 m, with 14 m drain spacing. The drainage pipes were covered with gravel (0.2 – 4 mm). The profile view presents how the lateral drains are connected to a main drainage pipe (around \varnothing 160 mm) that leads drainage water into a collector/drainage well (internal diameter \varnothing 600 mm, height 220 cm). Although the agricultural field is very flat (\sim 1.0%), two drainage wells/collectors are present in the field, based on topography. Both wells virtually divide the drainage occurring from the entire field into two from the position where drainage well AA is in the field. Thirteen lateral pipes were connected to a drainage pipe that drains into a drainage well AA, as shown in Figure 1. Whereas the remaining lateral pipes drain into another drainage well AV (Figure 1). All the drainage from the field takes place from only one drainage ditch adjacent to the field marked as D1 in Figure 1. However, the field area is surrounded by other drainage ditches either provided for the adjacent agriculture fields or a divide between the fields with different land uses, such as small forest field. These fields have the potential to influence groundwater levels in the field, which could affect the subsurface drainage system. Figure 2 presents the pictorial details of the subsurface tile drainage system installed at the field.

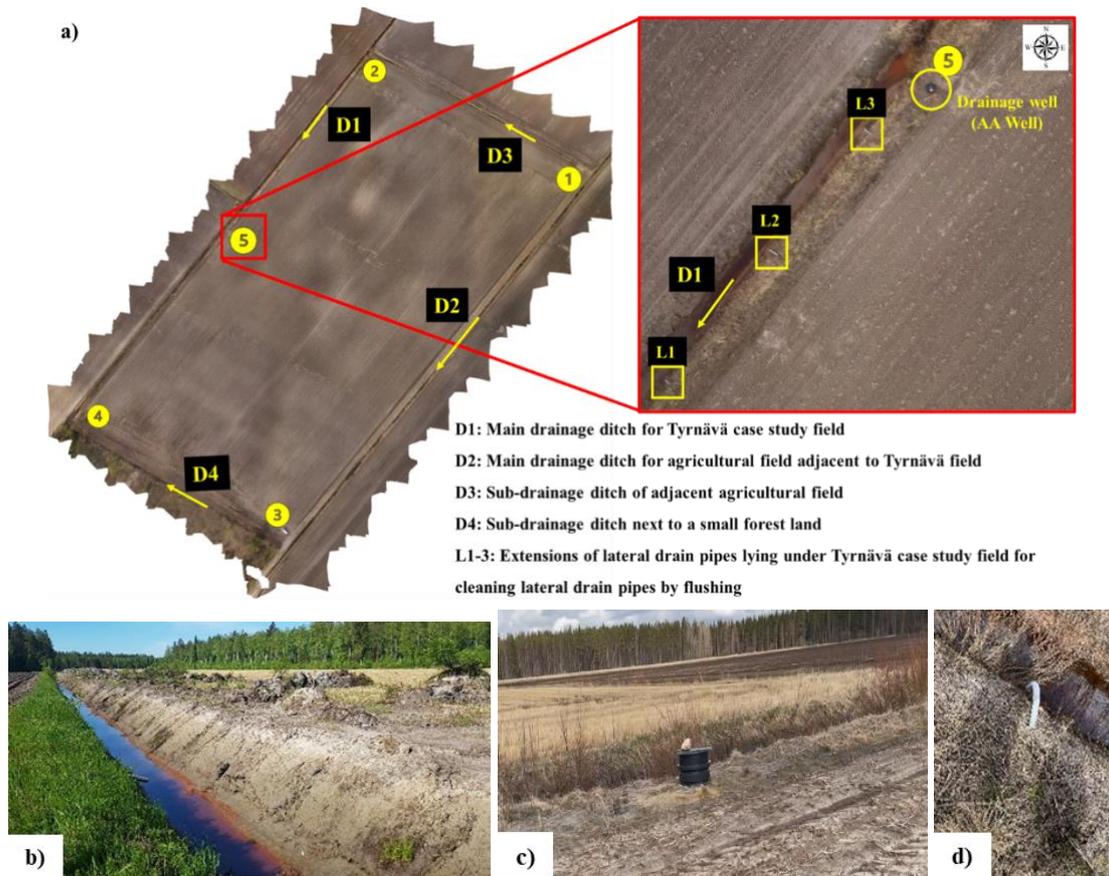
Figure 2. Finland I: Tyrnävä Case Study Field description. a) Orthographic view of tile drainage system; b) Main drainage ditch; c) One Drainage well / collector (AA Well) in the field (location point showed as 5 in Figure a); d) Extension of lateral drainage pipe installed in Tyrnävä field (L1-3 showed in Figure a).

Overall, the installation of hydrometeorological monitoring sensors was carried out at five different locations in the field, as indicated in figure 2. The orthographic view of Tyrnävä study field can be seen in Figure 2a. The extension of the lateral pipes lying under the field facilitates cleaning by flushing (Figure 2d). The main drainage ditch that was cleaned in 2021 can be seen in figure 2b, drainage well AA can be seen in Figure 2c, and Figure 2d shows the extension of one lateral pipe.

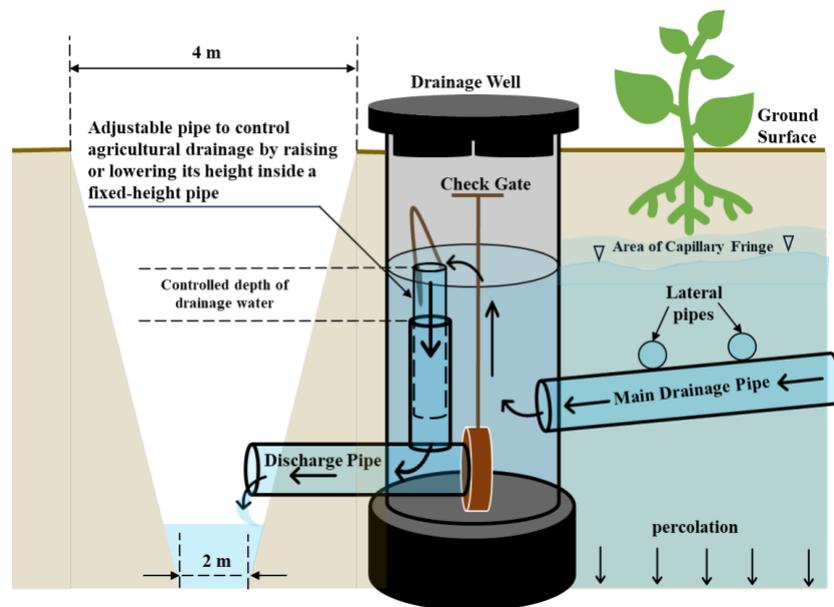
Figure 3. Schematics of controlled drainage well to collect water draining from the network of laterals, then to the main drainage pipe and then into the drainage well where the depth of water draining from the well can be controlled before it will drain out into the drainage ditch.

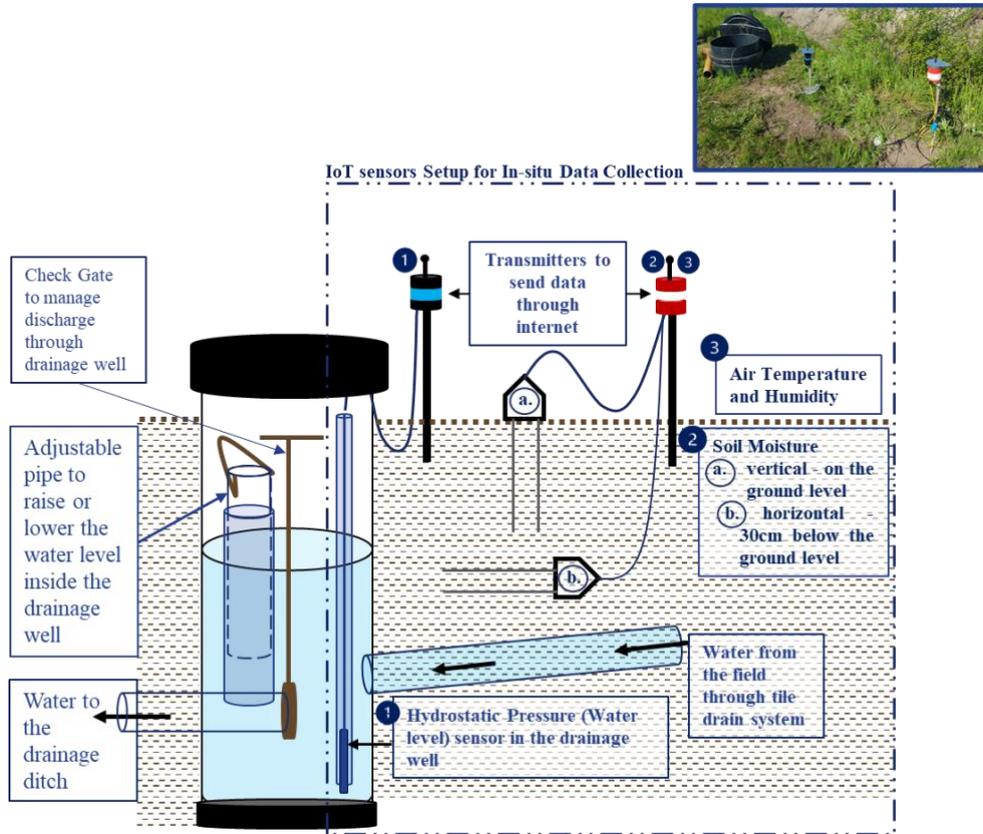
Figure 4. The installation setup of hydrometeorological monitoring in the Tyrnävä case study field

Figure 4 illustrates the monitoring setup in place during the crop season 2021 for soil moisture (% volumetric water content) data collection at two different depths (i.e., 20 and 30 cm below ground level), the water level in the drainage well / collector (hydrostatic pressure in cm), air temperature and relative humidity.

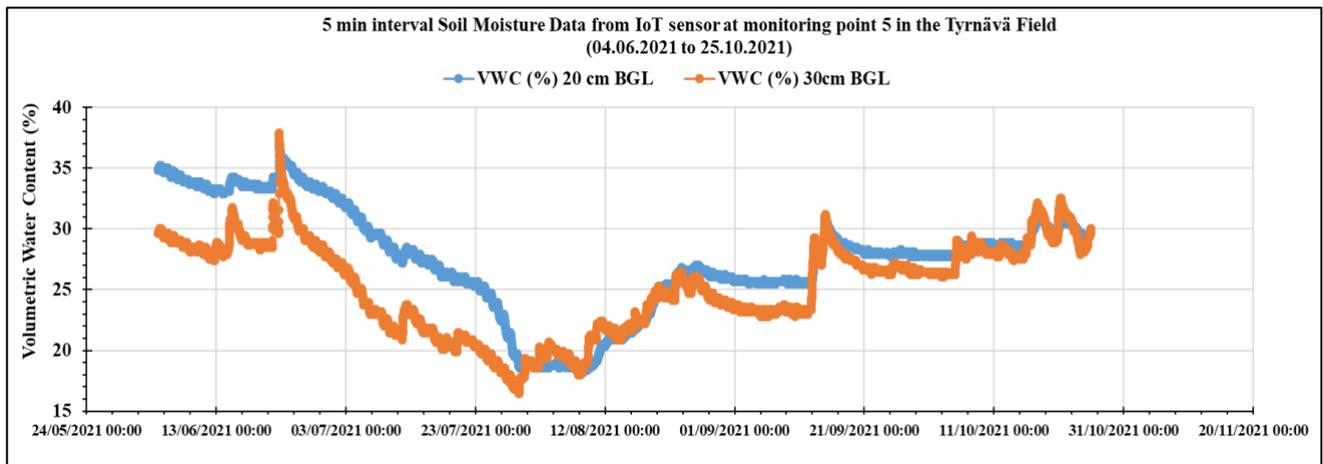
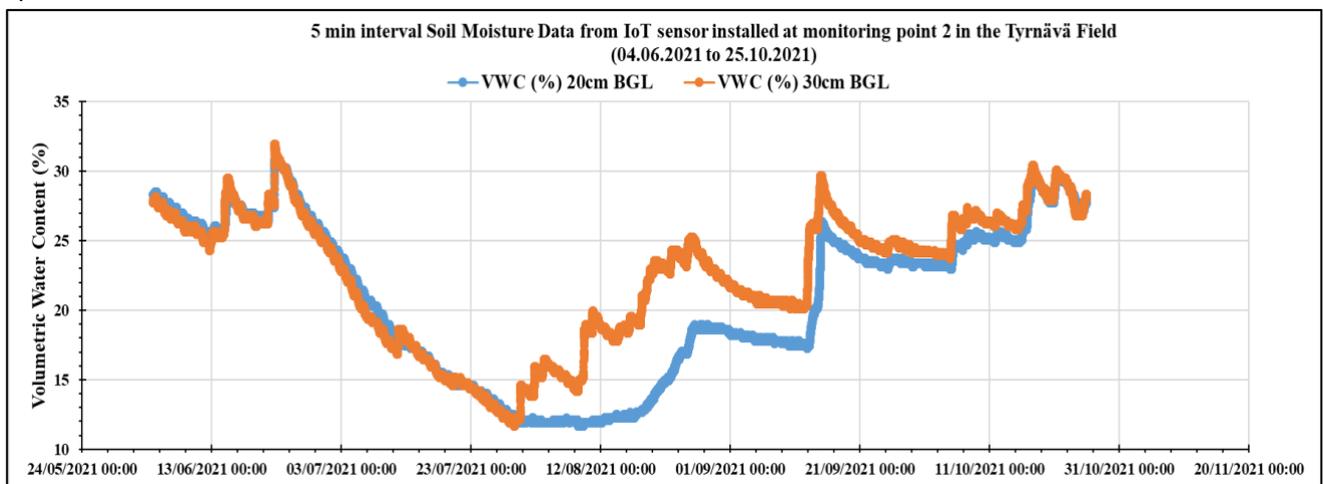
Figure 5. Soil moisture data collected from the Tyrnävä Field using IoT-based sensors. a) shows the soil moisture trend recorded at monitoring point 5 near AA Well. b) shows soil moisture data collected at monitoring point 2 in the Tyrnävä case study field (for locations, see Fig.2).

The data collection for monitoring these hydrometeorological parameters in the field was carried out between June 4th, 2021, and October 25th, 2021, at 5 min intervals (Figure 5).

For soil moisture data, two *Campbell-CS650 Soil moisture sensors* were installed at two different locations in the field, point 5 (Figure 5a) and point 2 (Figure 5b). For water level data in the drainage well, a *Submersible OEM-Pressure Transmitter BD sensor 18.605 G* (Developed by the Intelligent Machines and Systems research unit at the University of UOULU) was installed for two drainage wells in the field. The data was collected using cost-effective sensors which transmit data using LoRaWAN technology. The sensors were developed by the Intelligent Machines and Systems research unit at the University of UOULU and were used in a previous project (TIMAKO) as well.

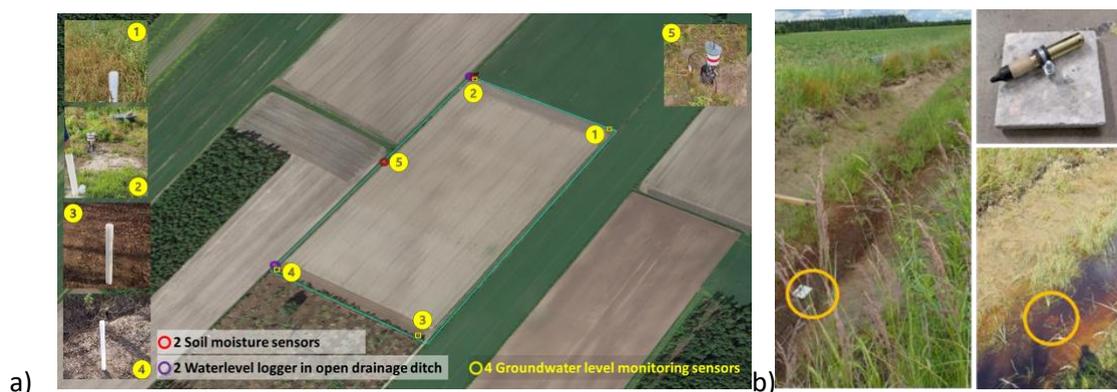
Figure 6. a) The picture shows locations where groundwater level monitoring pipes, soil moisture sensors, and water level loggers in the drainage ditch were installed at the Tyrnävä field scale. b) water level loggers installed in the main drainage ditch of the case study area (WATERAGRI project).

A total four number of *Solinst Levellogger 5 (Model 3001)* and 1 *Solinst Barologger 5 (Model 3001)* are installed, and the monitoring is ongoing. Another two water level loggers were placed in the main drainage ditch that drains out the agricultural runoff from the Tyrnävä case study area through two drainage wells. 2 *Campbell soil moisture sensors* were also installed into the drainage ditch D1 as shown in Figure 2. Among all the offline data loggers installed in the field, data from three loggers installed in the groundwater pipes (GWp1, GWp2, and GWp4) were collected.

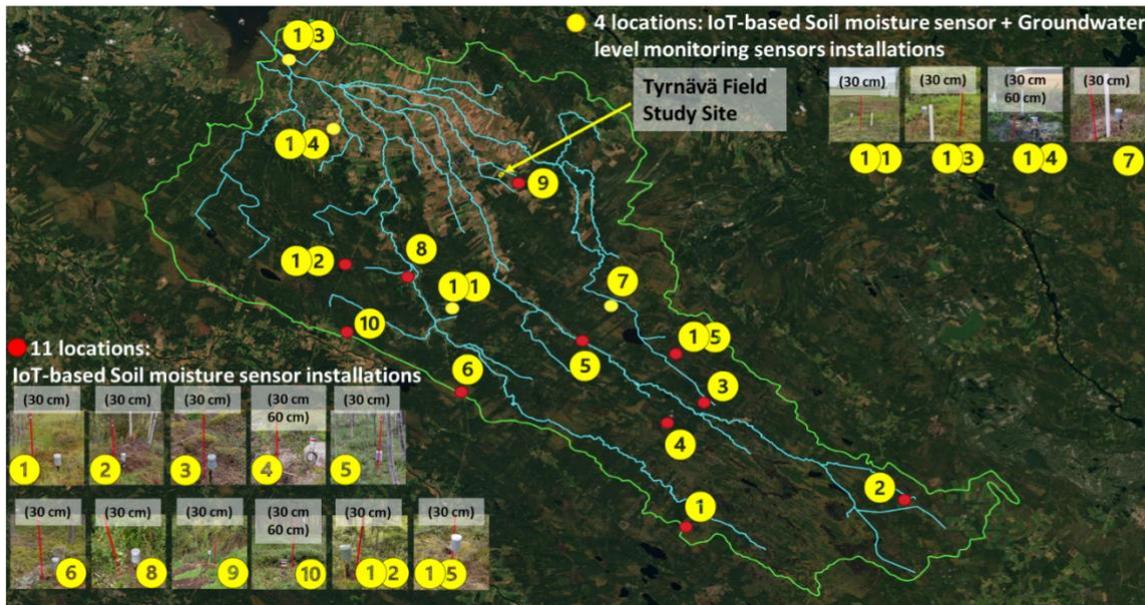
Figure 7. The picture shows the locations where groundwater level monitoring pipes and soil moisture sensors were also installed in the Temmes catchment (that are available from the Waterline project).

Figure 7) excluding four at the Tyrnävä field. 4 Solinst Levellogger 5 (Model 3001) and 2 Solinst Barologger 5 (Model 3001) were installed in the groundwater pipes. Moreover, IoT-based soil moisture monitoring sensors were installed at 15 locations, excluding the two at the Tyrnävä Field scale. Among the 15 locations, the Campbell-CS650 soil moisture sensors were installed at 3 locations which provide the soil moisture data from two different depths below the ground surface. Whereas, at all other locations, Decentlab DL-TRS12 soil moisture, temperature and electrical conductivity sensors were installed, which gives the soil moisture readings from only 30 cm depth below the ground surface.

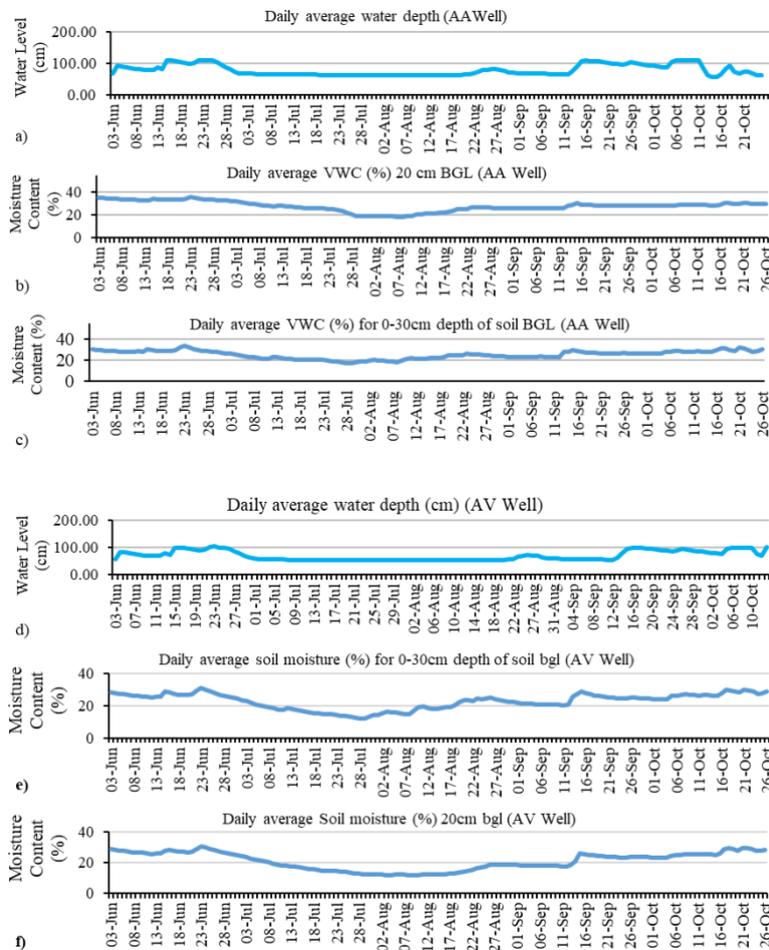
Figure 8. a) daily average water depth observed in AA well during crop season 2021, b-c) daily average soil moisture (%) 20cm and 0-30cm below ground level from sensors installed near AA well. d) daily average water depth observed in AV well during crop season 2021, e-f) daily average soil moisture (%) 20cm and 0-30cm below ground level from sensors installed near AV well.

Figure 8a-f presents the daily average soil moisture data and water level data calculated from a daily 5-min interval dataset recorded in the Tyrnävä field during crop season 2021.

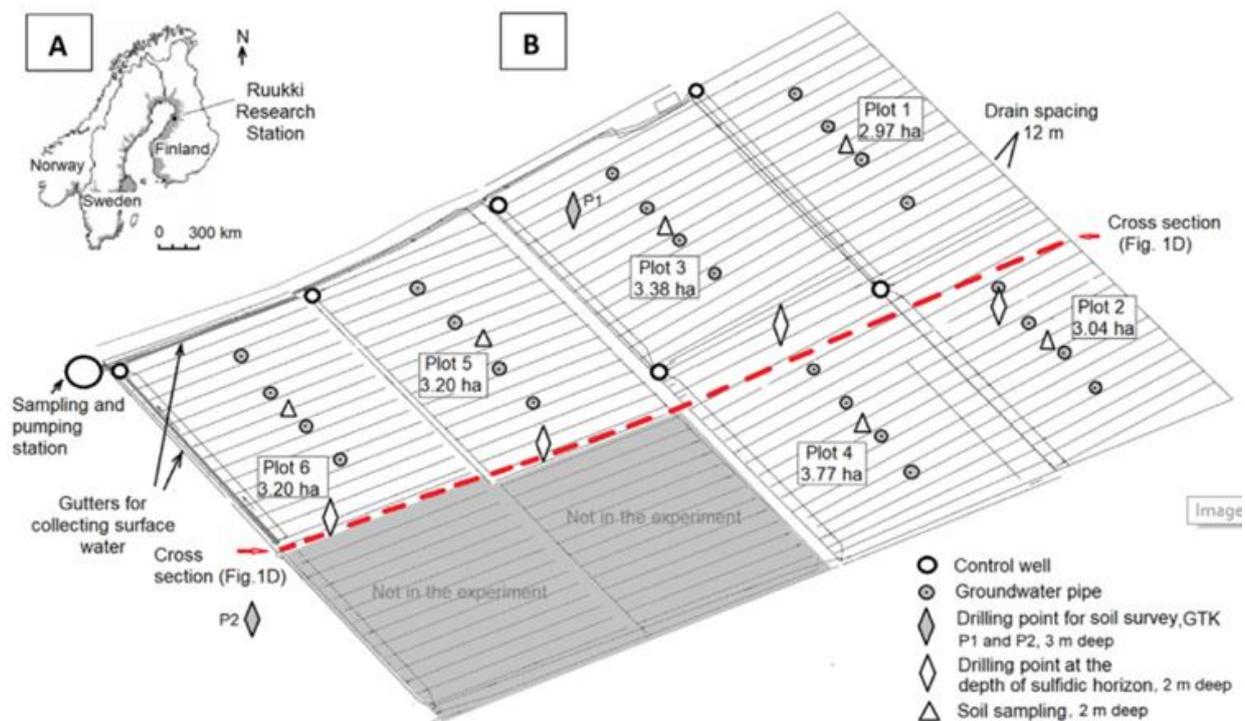
Figure 9. A) The location of the Ruukki field, with the shaded area, shows the potential location of acid sulfate soil. B) The drainage setup and soil survey map of the Ruukki experimental field (Yli-Halla et al. 2022).

The groundwater table level (GWTL) of the plots can be controlled by adjusting the height of the outlet pipe in the control well. From each control well, a separate outlet pipe conveys water to the sampling station at the lower end of the field. In this area, rust precipitates constantly and clogs the drainage pipes; therefore, every lateral has a joint tubing that extends to the soil surface and can be used for flushing rust out of the pipes. In plot 6, surface runoff waters can also be collected using two surface runoff gutters in the corner of the plot, then channelled into the sampling station.

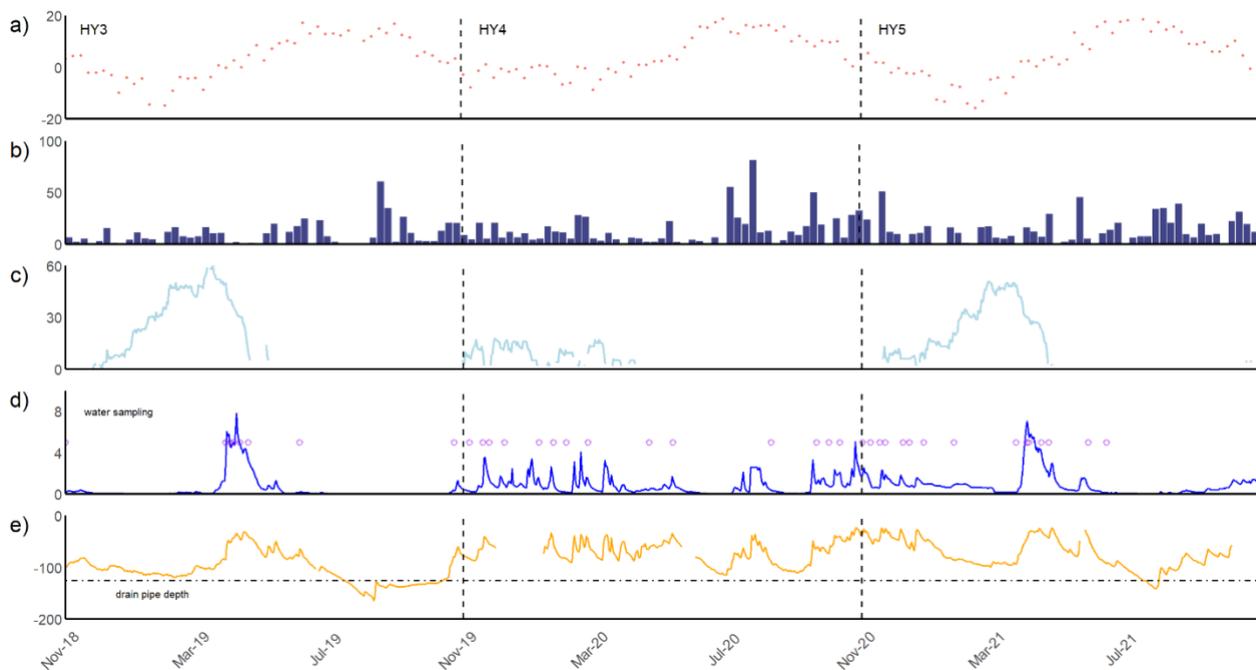
Figure 10. a) Weekly average temperature ($^{\circ}\text{C}$); b) Weekly average precipitation (mm); c) Daily snow depth (cm); d) Field average specific subsurface discharge (mm); e) Field average groundwater depth (cm)

The three-year monitoring period (2019-2021) of the field started with a dry year (455 mm in precipitation), followed by two rainier years (669 mm and 684 mm, respectively) when compared to the 30-year average precipitation 1991-2020 (555 mm). The mean runoff ratio (percentage of precipitation that ended up as subsurface discharge) of the field was 38% (2018-2019), 43% (2019-2020) and 50% (2020-2021). During the three years of observation, subsurface discharge rates in all plots were typically high for a brief period from the end of March until mid-May (due to snowmelt) before dropping to very low during June – early August (warm period with low precipitation, and the drainage control wells were closed to prevent excessive reduction in groundwater level from evapotranspiration, even then groundwater level can drop past two meters depth in some plots), then increased moderately in late autumn and winter (due to storms that flooded the system, and the opening of the control wells typically in November). The spring melting of winter-accumulated snow and frost was responsible for most of the peak discharge rates over the years and provided a significant portion of the field's annual discharge (averaging 62% of annual total discharge). The discharge rate for these melting periods could get as high as 10 mmd^{-1} or $100 \text{ m}^3 \text{ ha}^{-1} \text{ day}^{-1}$ (plot 4, 2019) or $108 \text{ m}^3 \text{ ha}^{-1} \text{ day}^{-1}$ (plot 4, 2021), and GWTL showed saturation in the field. The period from winter 2019 to spring 2020 experienced an unusually warm winter, with snow cover building–melting cycles frequently occurring on the field (Figure 10). As a result, discharge was significantly higher during this winter (occurred in multiple smaller discharge peaks), and the spring melting discharge rate was significantly lower than usual. Aside from that, snow cover and frozen soil typically lasted from late November until early May. However, soil frost measurements revealed that frost only reached -30 – 50 cm depth underground, thus, 50 cm or more of soil depth above the drainage pipes was never frozen, allowing water to enter the drainage pipes. During winter, the control wells were open, thus, discharge and leaching occurred.

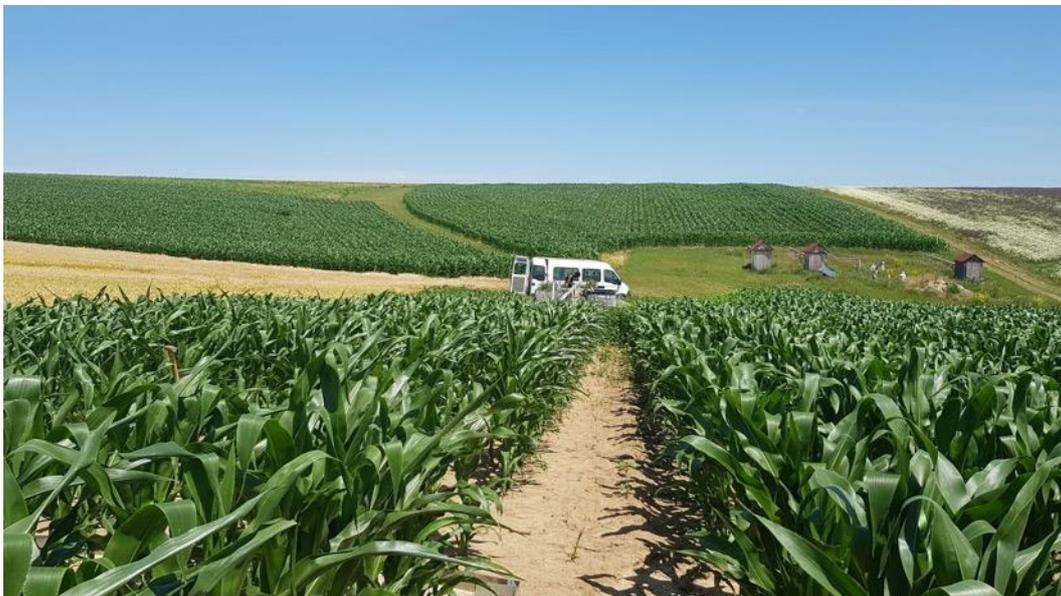
Figure 11. Experimental site of the bio-inspired filter treating agricultural runoff, Mistelbach, Austria. Photo: June 2022.

The bio-inspired multilayer filter system was designed and installed in an agricultural area in Mistelbach, Lower Austria (*Figure 11*). The mean annual precipitation in the area is 650 mm, and the mean annual temperature is 9.5°C. Klik and Rosner (2020) referred to a long-term mean annual rainfall of 621 mm for the period 1994-2018, 405 mm of which occurred in the growing season (May - October). The soil texture was identified as sandy loam, and the predominant soil type is Tschernosem (Kupelwieser, 2022). There are no drain tiles on the field. Due to the location of a slope, surface runoff occurs. In the vicinity of the pilot installation, previous studies have been carried out in the past on soil erosion, surface runoff, and nutrient and pesticide losses due to erosion processes from BOKU (Klik & Rosner, 2020).

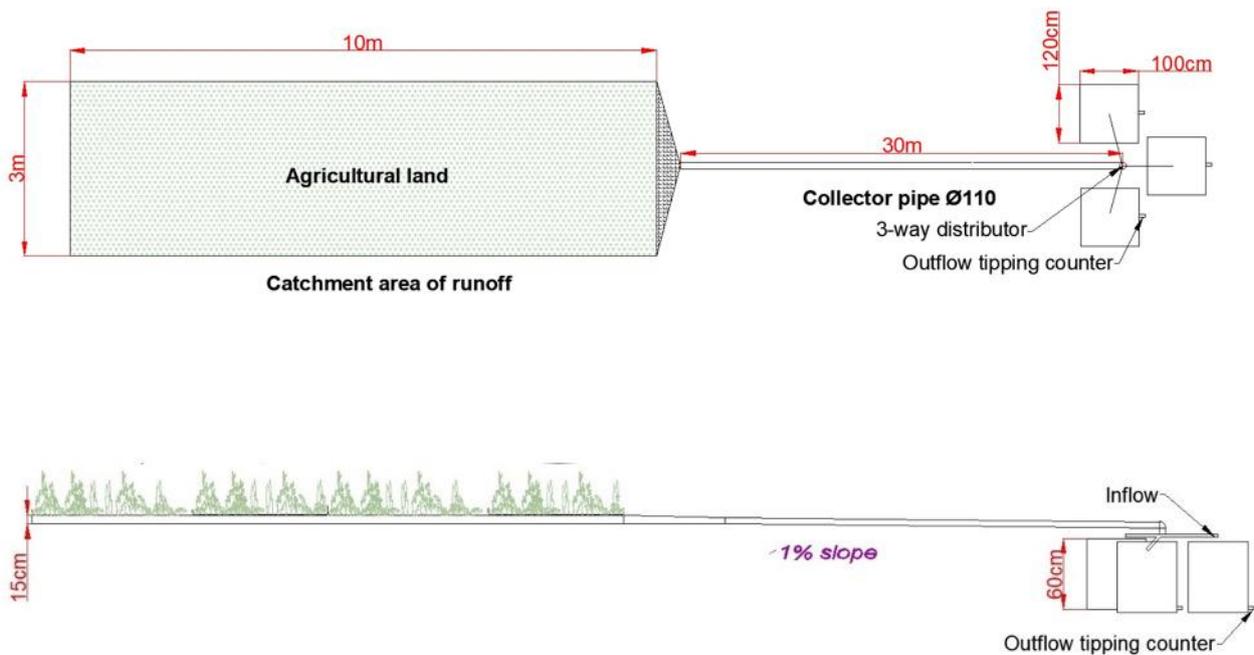
Figure 12. Top and lateral view of the catchment area, water collection pipe, the bio-inspired multilayer filter system, and a PV island (not shown) in Mistelbach (Austria II).

top of the filter systems by gravity. The agricultural run-off area had dimensions of 10m x 3 m. It was confined by steel plates (1.5 mm thick, 2 m long) hammered in the agricultural land after spring sowing with maize to mimic natural conditions. A triangular steel funnel was aligned at the same land surface level, and its outlet was equipped with a net before connecting to the collecting pipe (*Figure 12*). The catchment area was connected with filter systems using 30 meters of PVC pipes (Diameter 150 mm, length 3 m each, ten pieces) attached to reach the filter systems.

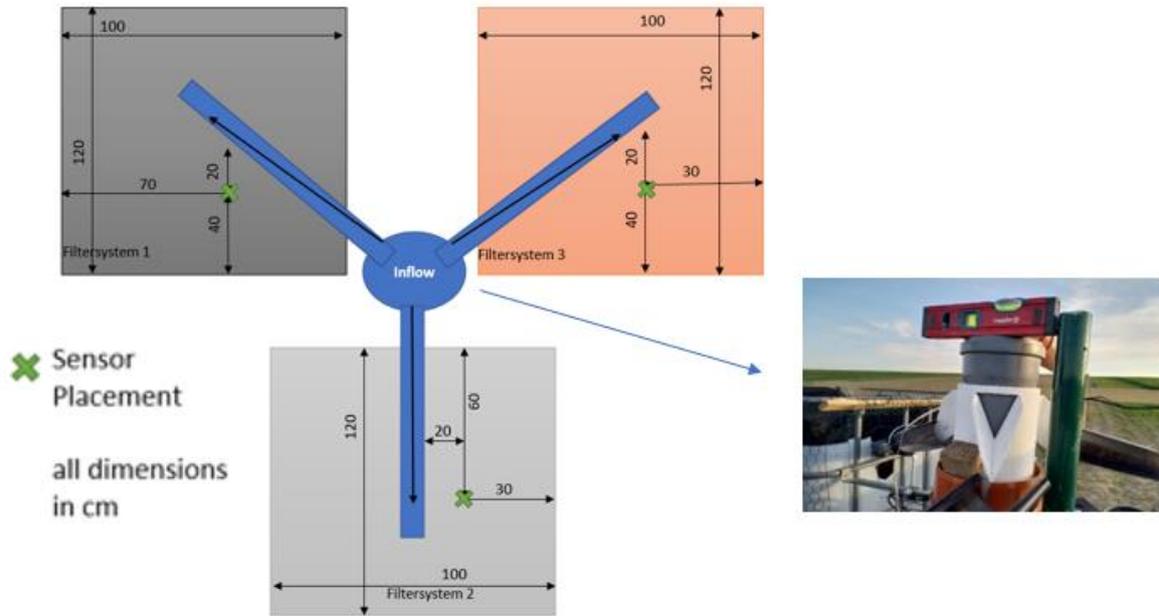
Figure 13. Arrangement of the three-way-water diverter in blue colour and position of soil sensors.

The collected agricultural runoff was distributed on top of the filter systems using an in-house developed water distributor with a mechanism to divide the water into three parts (one for each filter system). The distributor was designed based on a triple symmetrical (around the vertical axis) cylinder, where water enters concentrically and, after being calmed by passing through a vertical barrier, exits through 3 triangular outlets at the free drop (*Figure 13*).

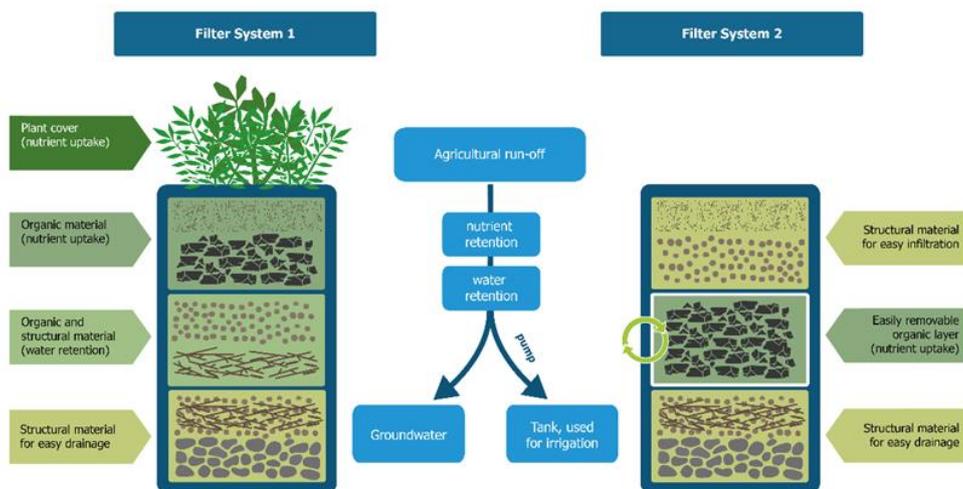
Figure 14. Bio-inspired filter system concept (alchemia-nova GmbH)

Bio-inspired multilayer vertical-flow systems were constructed above ground in three intermediate bulk container (IBC) tanks in June 2021 on agricultural land, each having a surface area of 1.2 m² and 0.65 m filter height composed of different layers of substrates. Filter 1: a vegetated filter system (with Draingarden and biochar), Filter 2: unvegetated filter (with biochar in the main layer); Filter 3: a vegetated system with local soil as reference. Designs and information for each layer are given in Figure 14 and Figure 15. The surface agricultural run-off was collected from a catchment area of 30m² (1% slope) and directed with a 30 m long pipe in a three-way distributor, which fed each system with surface runoff.

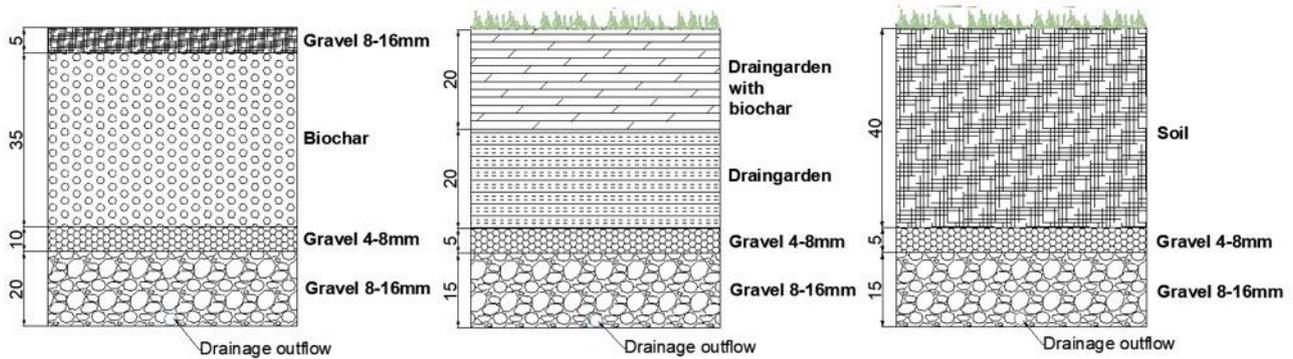
Figure 15. Layer composition (cm) of each filter: biochar, Draingarden, and soil filters in Mistelbach, Austria.

Bio-inspired multilayer filters (C2) in the Mistelbach case study are differentiated based on the substrate used in the main layer and the presence or not of vegetation.

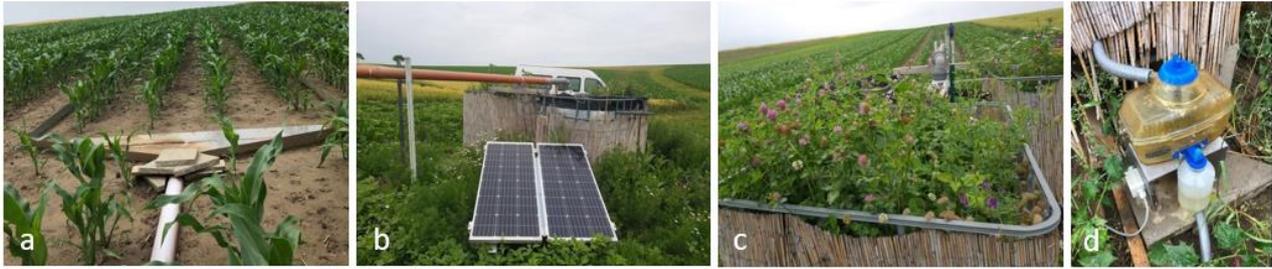
Figure 16. Catchment agricultural area, view of the agricultural runoff pipe that distributes the water on top of the three filter systems, PV island, vegetated filters, and tipping counter for effluent. 09.06.2022, Mistelbach, Austria.

The installation splits into three parts (Figure 16): a) the catchment area, including pipes; 2) the filter array with water distribution; 3) the photovoltaic island with monitoring sensors. The catchment area can be installed either with or without vegetation. The metallic sheets that isolate the catchment area must be driven in with a heavy mallet and protective block. It is recommended to do this after a rain event as moist soil is more penetrable. The catchment area had a slope of 1%, and its dimensions were 10m long along the hill slope and 3m wide. The piping starts with the collection funnel at the very end of the catchment area. The pipes require rammed feet every 3 meters for stability.

Due to the remoteness of the place, a PV island provides electrical power and shelter for monitoring equipment all on one pallet. The parameters measured were water outflow quantity, soil temperature, and moisture. A hydro switch triggers the measurements inside the pipe. This switch turns on once a 15cm long water film closes the contact between two poles and gives the start signal for measurement. The monitoring runs as long as there is a water flow and stops 12h after the water stops running to monitor the hydraulic behaviour of the filters after a rain event.

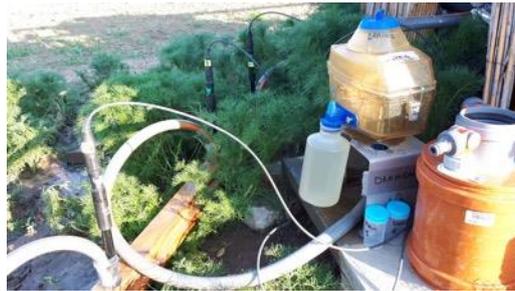
Figure 17. Tracer experiment on 12.05.2022, three EC meter probes were placed in effluent cells and measured for 48 hours the effluents' electrical conductivity.

A tracer experiment using saline water was carried out from 12 – 14th May 2022 on all three filter systems (biochar, Draingarden, soil filters). A 1000 L water tank was brought into the field by the farmer to perform the tracer tests and placed uphill in the catchment area so water could be led to the systems by gravity. Because there was not enough pressure to mimic desired flow, influent loading was done manually using a bucket with a valve in its bottom, directing the water in the perforated distribution pipe situated on top of the filter. Each filter system was first wetted with fresh water until there was continuous water running from the effluent (around 50 L). The tracer experiment method followed was similar to previous methods on similar systems (Langergraber, 2003). The tracer influent was prepared on-site, spiking tap water with NaCl until it reached an electrical conductivity of 25 mS/cm. Each filter received 50 L of tracer solution for 10 minutes. Following the tracer application, the filter was loaded with 50 L of fresh tap water; one, two, and three hours after the tracer application, a total of 150 L of fresh water. The electrical conductivity of each effluent filter system was measured continuously every 10 minutes for 48 hours, and data were stored automatically (Figure 17). Tracer results are shown in Section 3.3.5.

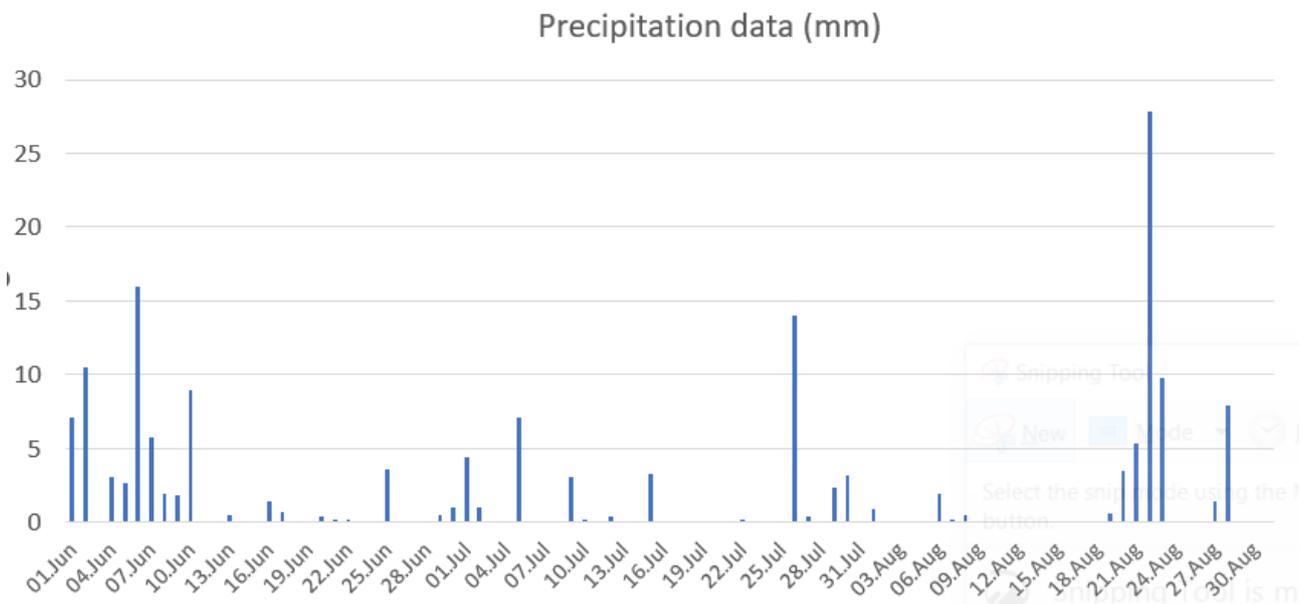
Figure 18. Precipitation (mm) per day during the period June – August 2022 in the Mistelbach area (Data source: visualcrossing.com).

Figure 18. It is important to point out two details: a) not every rain event produces runoff, and b) the rainfall data presented below are mean values of the Mistelbach area, not of the exact experimental location.

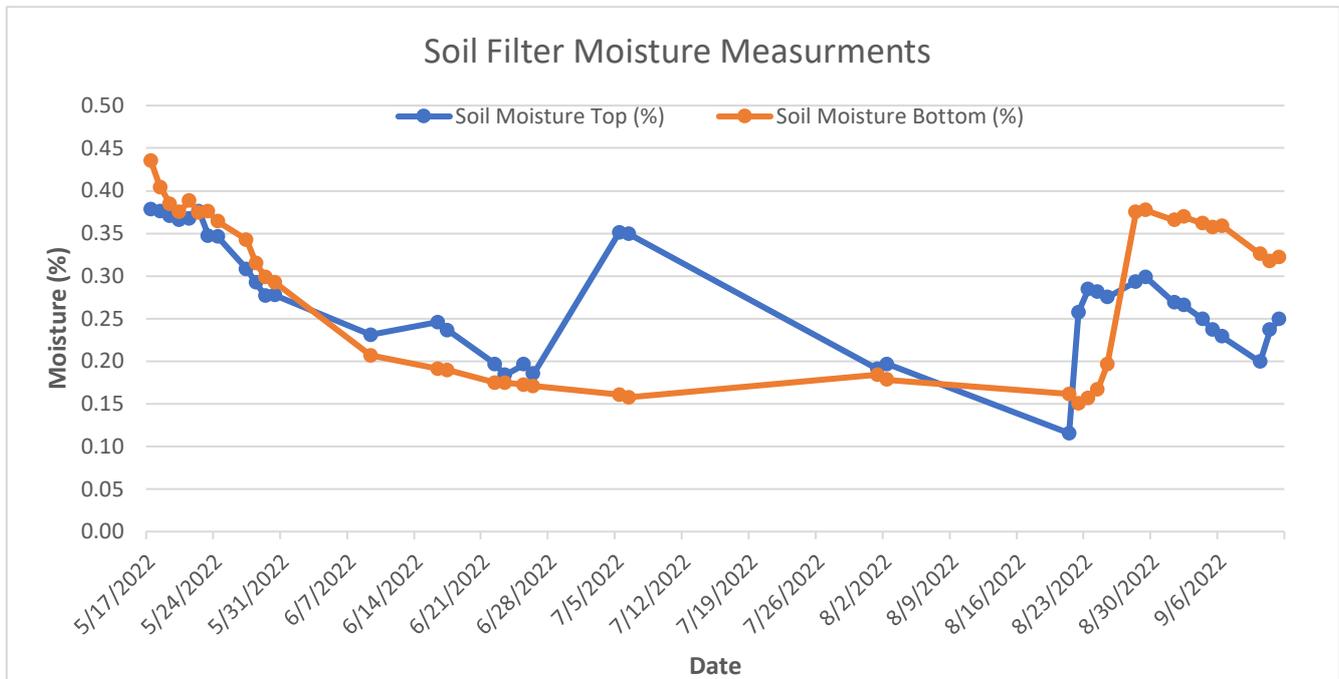
Figure 19. Soil moisture content (%) measured from sensors in two filter depths.

Moisture values from the soil filter ranged between 43% highest and 12% lowest. The points on the graph illustrate the logged measurements during the rain event on a given date (Figure 19). In the beginning, the filters were wet because of the tracer tests carried out on 12-14th May 2022, this explains the highest value of moisture content at the starting point. After that, both trendlines are decreasing during dry periods and increasing significantly, only corresponding to major rain events.

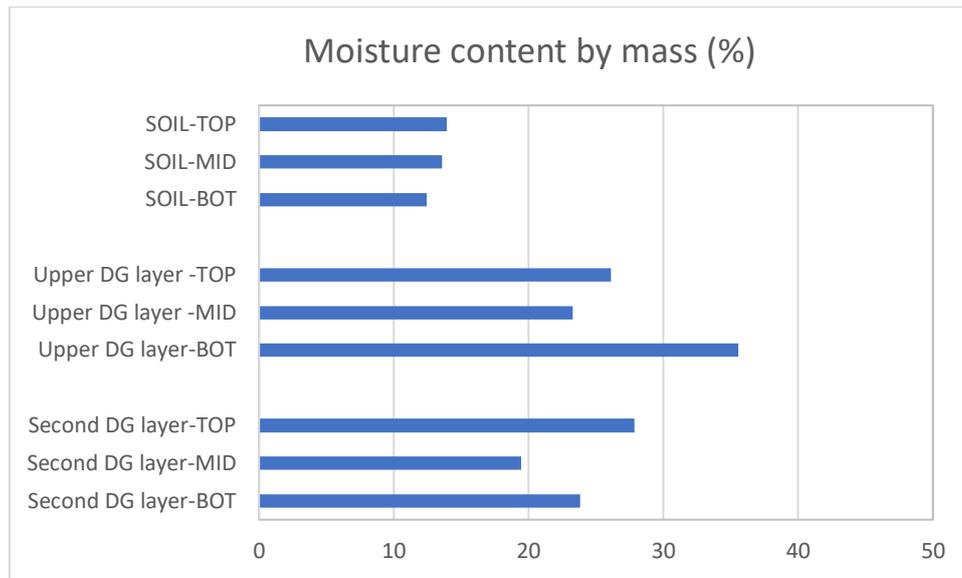
Figure 20. Substrate moisture content data which were collected from the main layer at different depths (every 10 cm) at the end of the experiment. Samplin: 06 Dec 2022. (Gravimetric water content by mass $(M_{wet}-M_{dry})/M_{dry}*100$).

The results of moisture content for Soil and Draingarden filters are presented in Figure 20. The results show that the moisture content of the soil filter was 14%, for the upper layer of the Draingarden filter was 23-26%, and the second layer of Draingarden had a moisture content of 19-28%. Biochar was the most moisture material by qualitative check, as well as from the sensor's measurement, biochar moisture values were higher than 100% (120%-160%).

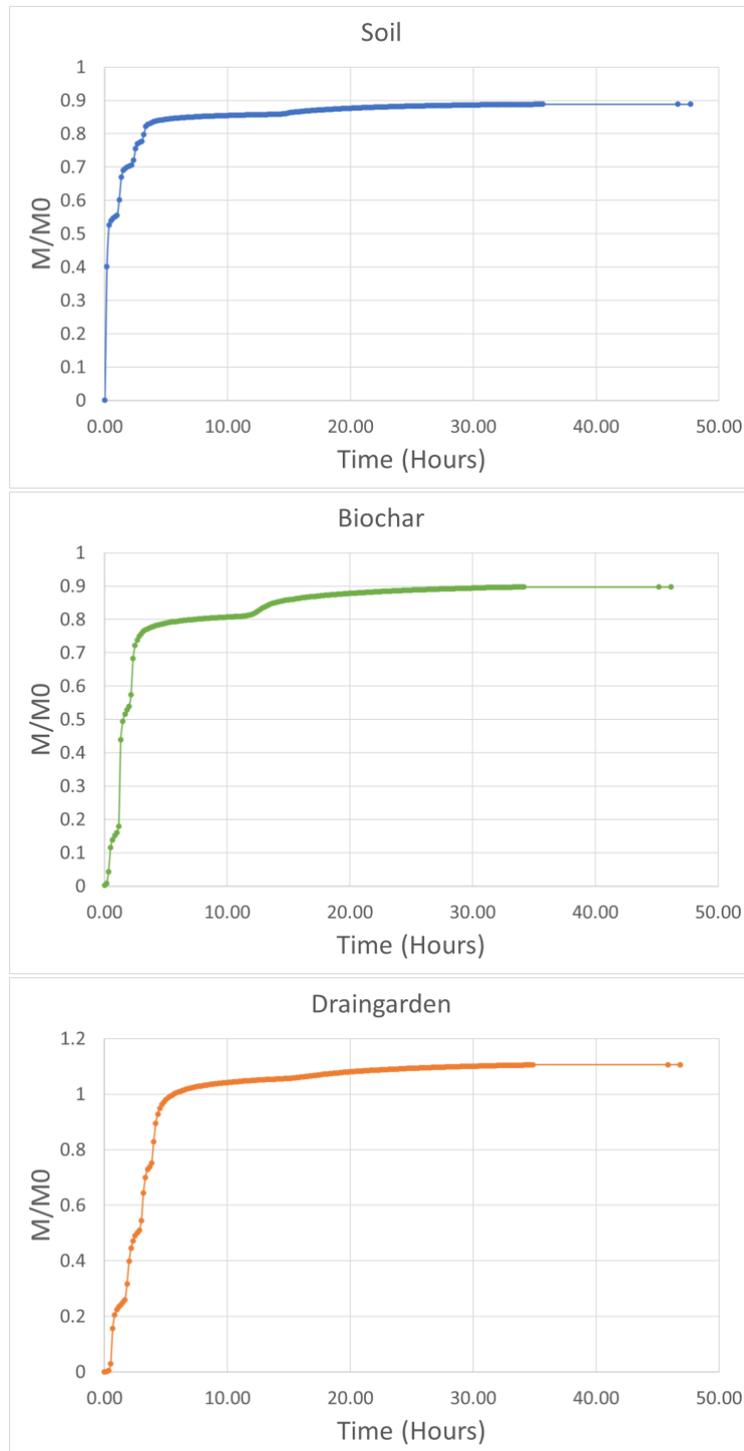
Figure 21. Tracer data results of the three systems in the Mistelbach pilot case study, Austria. 1) Soil filter, 2) Filter containing biochar in the mean layer, 3) Filter containing Draingarden material in the main layer.

The tracer mass recovery (M/M_0) results were plotted versus the time (Figure 21). Total tracer mass recovery was 90% for the soil and biochar filter and 115% for the Draingarden filter. Mass recovery higher than 100% is usually attributed to experimental error or background electrical conductivity data in the system (which, in this case, were deducted anyway).

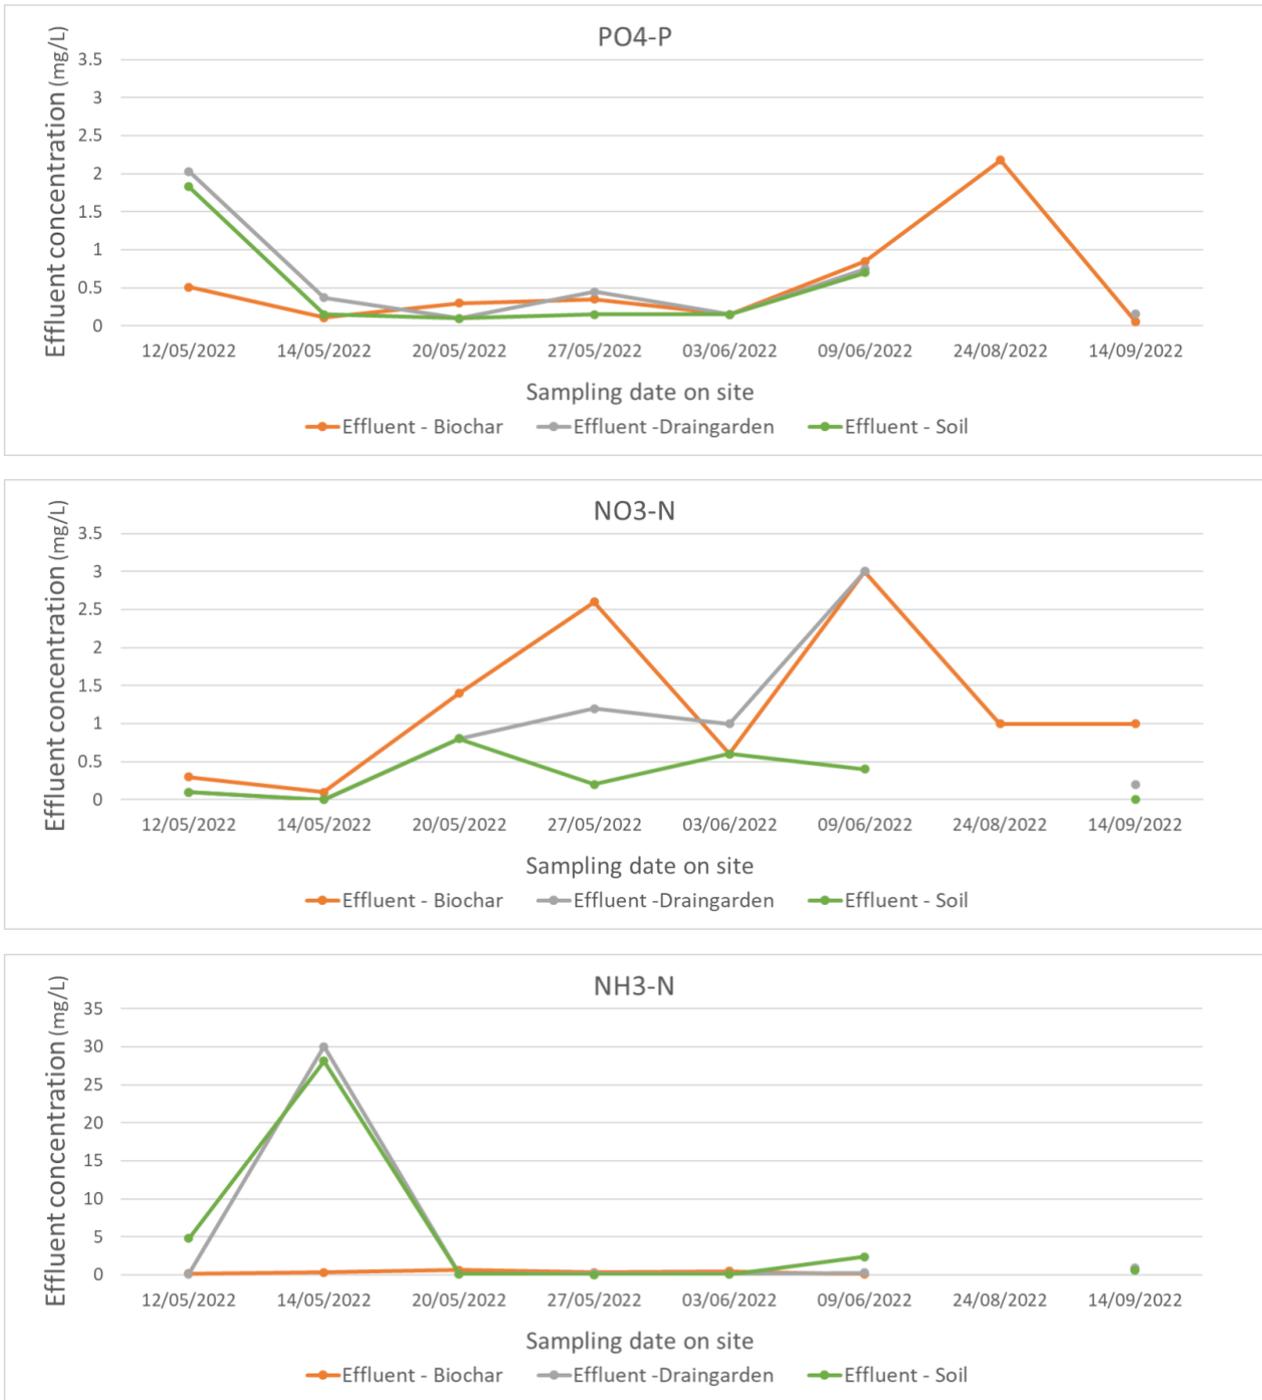
Figure 22. Effluent concentrations over time for PO₄, NO₃-N, NH₃-N, Mistelbach pilot study case (The visit dates where no effluent was found are not shown).
