WATERAGRI

D4.3: Description of Developed Drainage Technologies

M36, April / 2023

WP 4 Nutrient Recovery from Streams

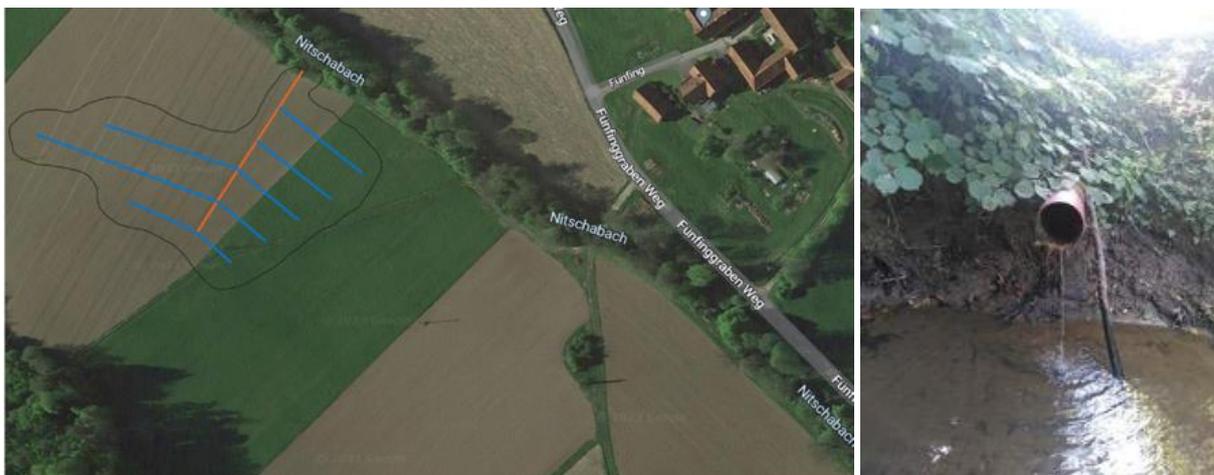
Figure 23. Site location, Gleisdorf, Austria III. The prototype was inserted in the drain pipe collector.

Near Gleisdorf/Styria/Austria (47.117587511658, 15.7889951203452), a subsurface drain water filter prototype was installed (Figure 23 and Figure 24). The respective subsurface drainage is laid out at a depth of around 70 cm and collects water from approximately 1ha of slightly sloped organic farmland. The filters are inserted in the last 2m of the main collection branch, just before the water is discharged into a bordering stream. The inclination of the drainage pipe is estimated to be 7% (Figure 24). The organic farm is cultivated with potatoes and fertilised in spring with organic fertilizer.

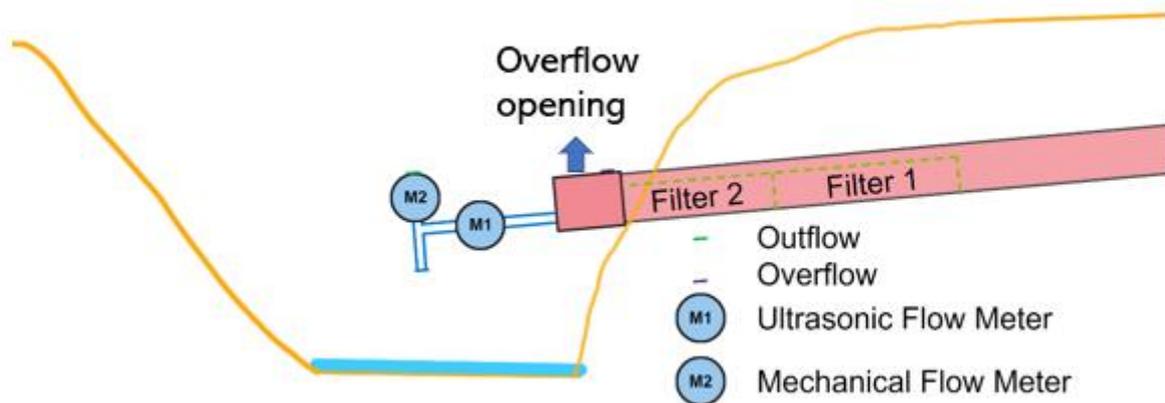
Figure 24. Schematic design of the two filter prototypes installed in the Gleisdorf drainpipe. Filter 1: zeolite 4-8 mm, Filter 2: Biochar from cherry seeds, M1 and M2 Ultrasonic and Mechanical flowmeters.

The system is designed to mimic a horizontal flow filter system but at a small scale and is inserted in the drainage pipe at the outlet (Figure 24). Drainage water flows through a filter structure and exits it. The cartridge filter structure is made using a 3D printer, and its final model was developed after producing different 3D printed structures (Figure 25). The drainage filter structure was designed based on site-specific parameters. The structure has precise dimensions to fit tightly in a drainage pipe. The system was installed in Spring 2022 and monitored in Summer 2022, and the monitoring campaign will also follow during Spring-Summer 2023.

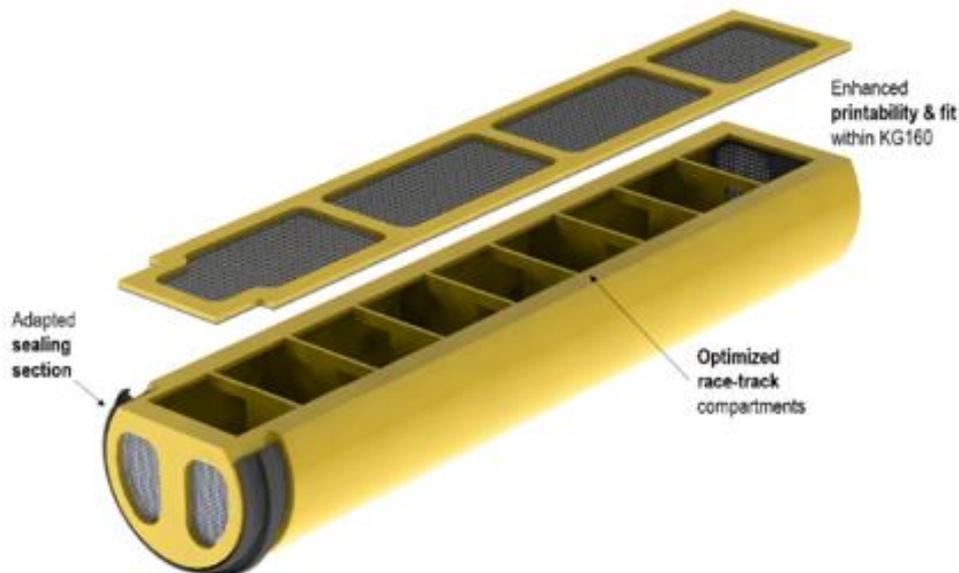
Figure 25. Prototype filter structure designed and produced by alchemia-nova (ALCN), inserted in the subsurface drainage pipe (Gleisdorf, Austria).

The nutrient concentration in the drainage flow was assessed for influent, effluent after the first structure, and effluent after the second structure (i.e., final effluent). Results from the first monitoring year, 2022, are presented in this deliverable. The data for the 2023 season will be shown in the updated version of deliverable **D5.3 Data collection**. A Master' student is currently doing column experiments at BOKU to quantify filter adsorption capacity under different flow rates. This data will support filter optimization in the monitoring year 2023 and arrive at better conclusions regarding the filters' nutrient retention capacity.

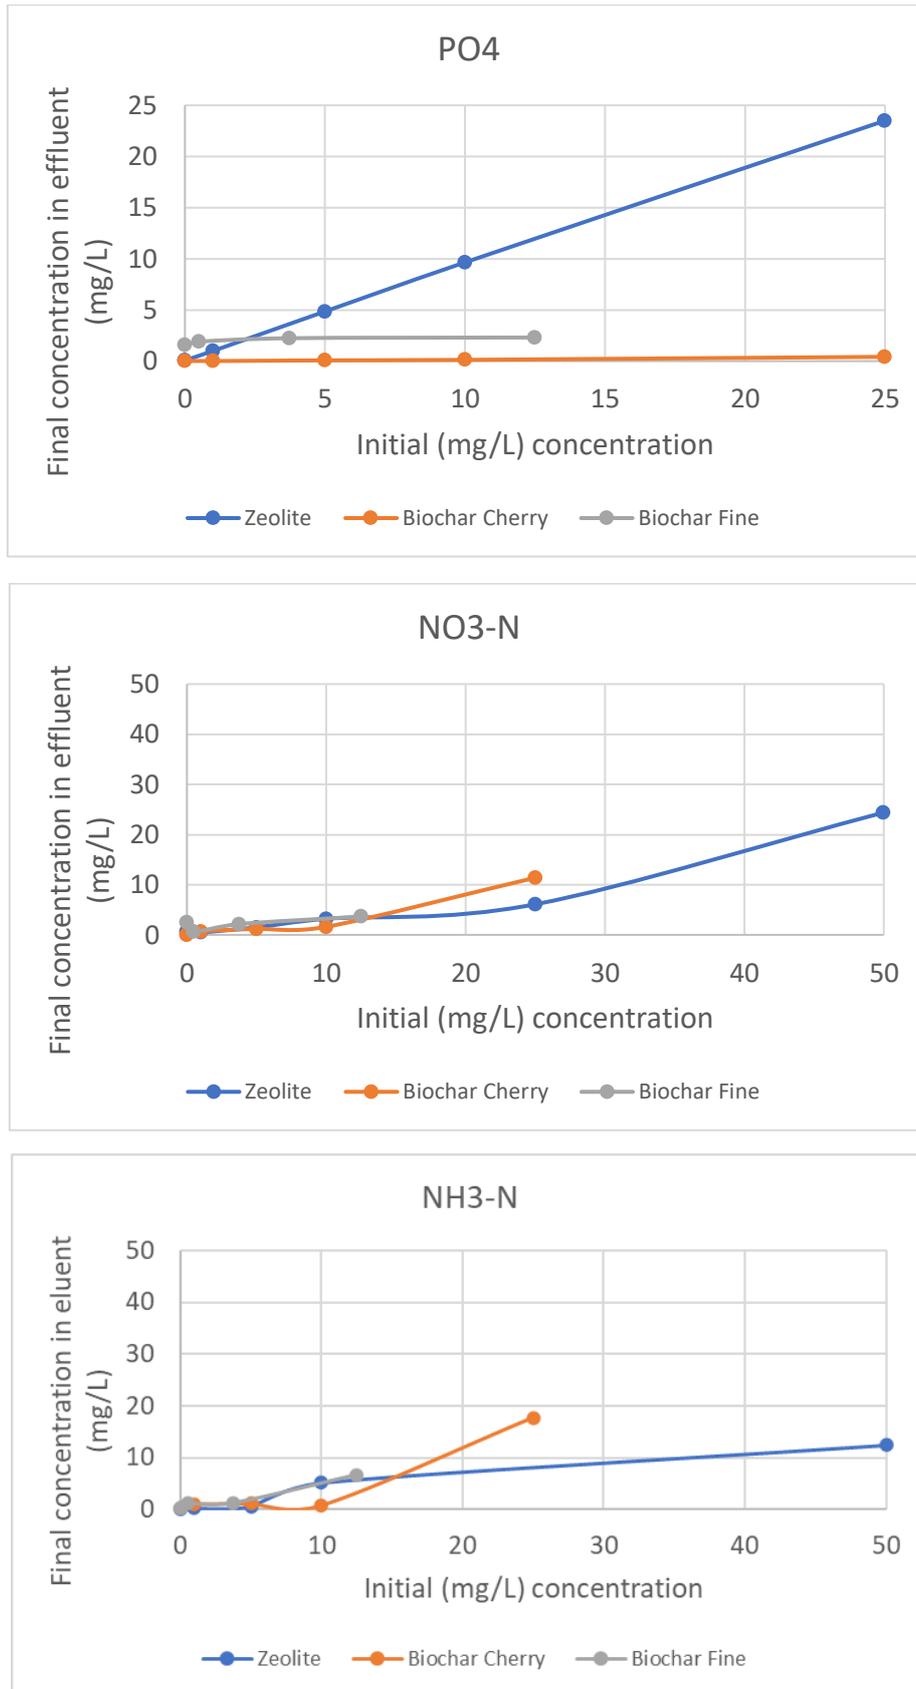
Figure 26. Sorption results performed in the laboratory of ALCN for Zeolite coated $Mg(OH)_2$ biochar from cherry seeds and $Mg(OH)_2$ -coated biochar finer texture of the same material as the one used in Mistelbach.

Prior to the field application, the substrates of zeolite and biochar were tested in the laboratory to assess the sorption properties of the material. Sorption curves for PO_4^{3-} , $\text{NO}_3\text{-N}$, and $\text{NH}_3\text{-N}$ were determined with a range of inlet concentrations varying from 0 to 25 mg/L. Biochar did not arrive at the saturation point at these concentrations; see results in Figure 26. The sorption curve for PO_4 shows that biochar from cherry seeds adsorbs more P compared to fine biochar. Zeolite is the least effective for PO_4 retention and retains 90% of $\text{NH}_4\text{-N}$ at 50 mg/L inlet concentrations. Column experiments are currently being planned at BOKU through a master's student to assess the nutrient capacity of zeolite and biochar under different flow rates.

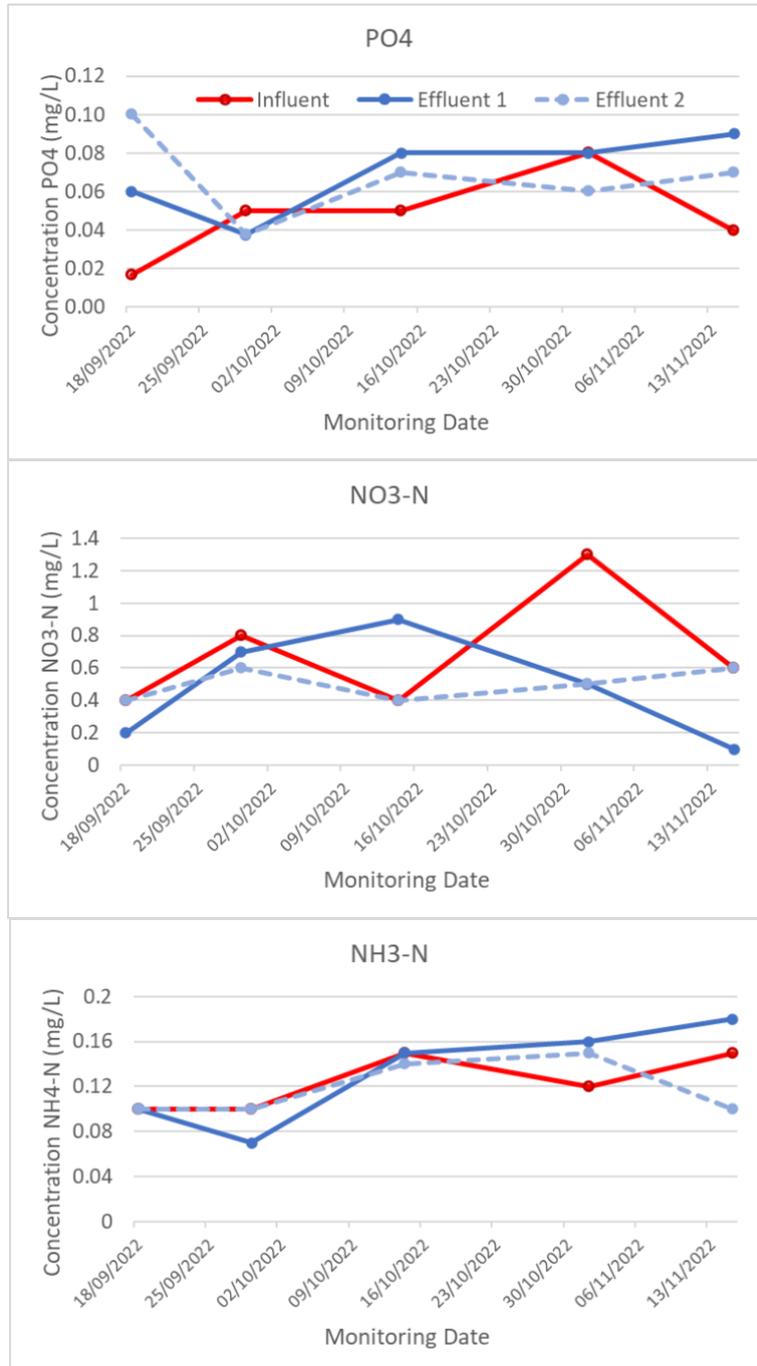
Figure 27. Influent and effluent concentration results of 3rd trial drainage filter system, Gleisdorf pilot case study. Monitoring of 3rd trial started on 7 July, but there was no water in the drainage pipe until 18.09.2022

The results of nutrient concentrations in the influent, effluent 1 after the first structure and effluent 2 after the second structure for the period 13.09 - 13.11.2022 are shown in Figure 27. The first filter inserted in the pipe had zeolite 4-8 mm, and Filter 2 had Mg(OH)₂-coated biochar from cherry seeds. Effluent after the second structure had almost always lower concentrations compared to the effluent of the first structure, indicating nutrient retention in filter 2 consisting of biochar. However, the Influent concentrations, which were generally low for all nutrients (0.02-0.08 mg/L for PO₄, 0.4-1.2 mg/L for NO₃-N, and 0.1-0.15 mg/L NH₄-N), were lower than the effluents sometimes indicating some leaching of PO₄ and N from the filter materials.

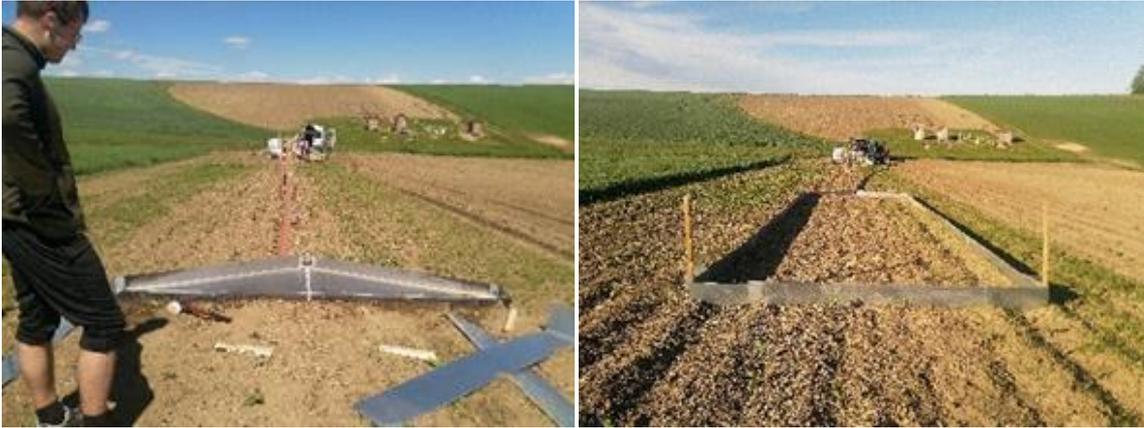
26.05.2021 Installation of the catchment area with dimensions: 3 x 10 m, using 1.5 mm thick and 2 m long steel plates.

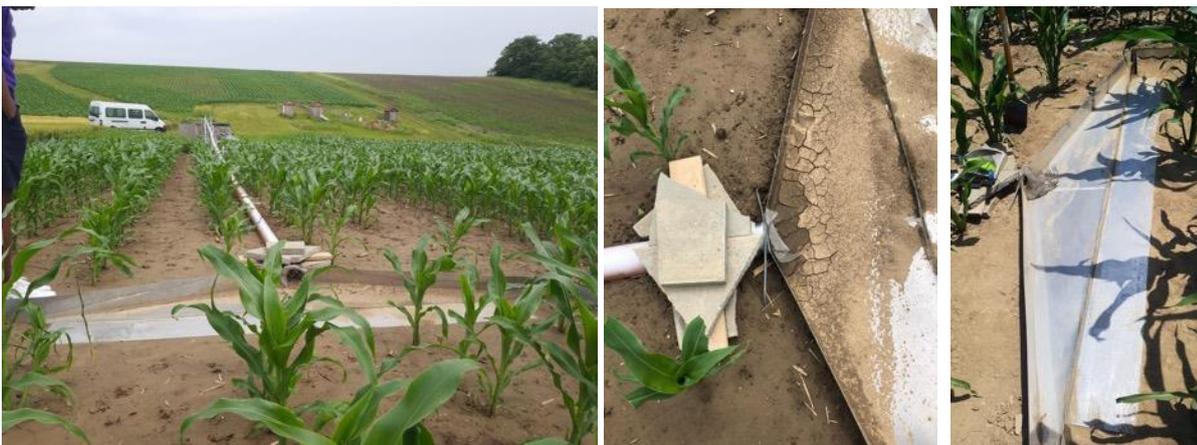
09.06.2022 The funnel that collects runoff at the end of the catchment area is cleaned from the soil sediments.

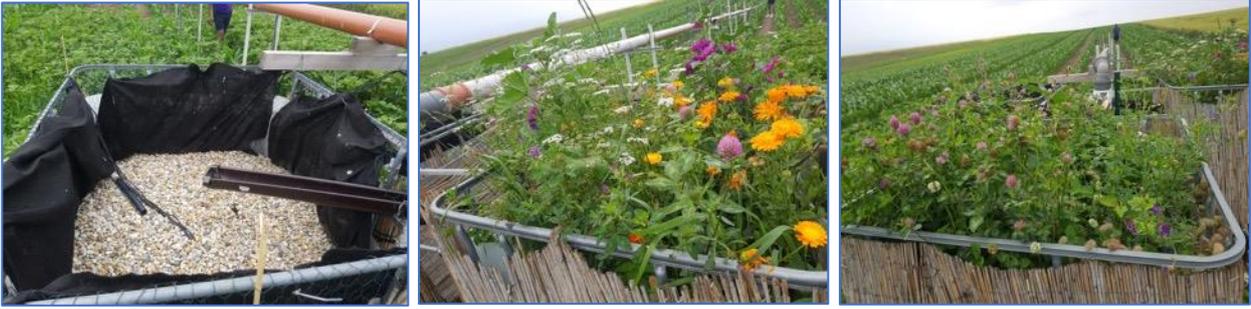
09.06.2022 Top view of the filters, from left to right: unvegetated biochar filter, vegetated soil, and vegetated Draingarden filter.

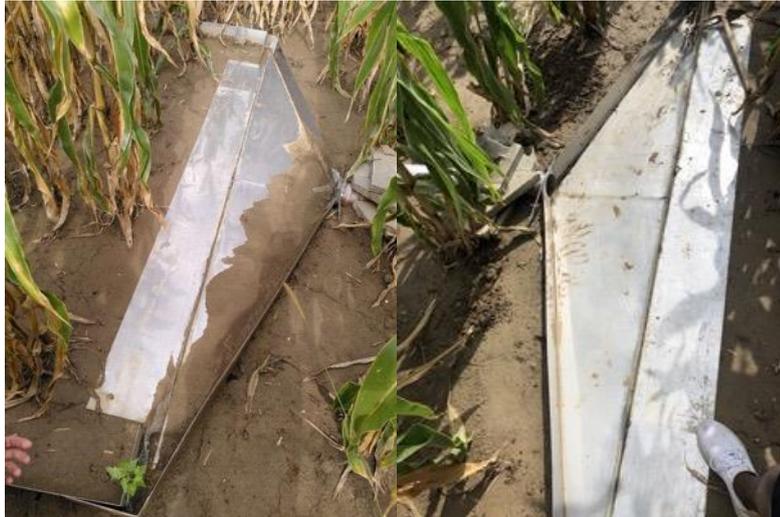
24.08. 2022 Site visit collector of runoff funnel before and after cleaning, and the last date of the monitoring period for Mistelbach. Filters were emptied on 6 December 2022.
